# Single Tooth Implant: Potential Pitfalls

*Mario Cabianca, DDS(?)*

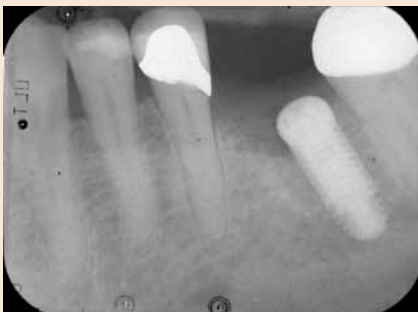
height of bone yet due to the posterior location, the surgeon must deal with limited access due to opposing dentition and limited opening. This can cause the dentist to incorrectly angulate the drill during the osteotomy preparation (Fig. 1). Radiographs can often prevent this situation from developing. In this instance the implant was removed and replaced with a wider diameter implant and the void was filled with grafting material (PepGen P-15 putty, Ceramed, Lakewood, CO) (Fig. 2). Primary

**FIGURE 1**—Distal positioned implant.

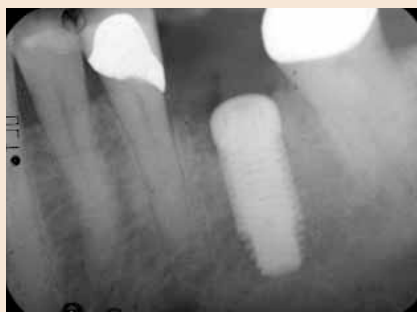
**FIGURE 2**—Correct angulation.

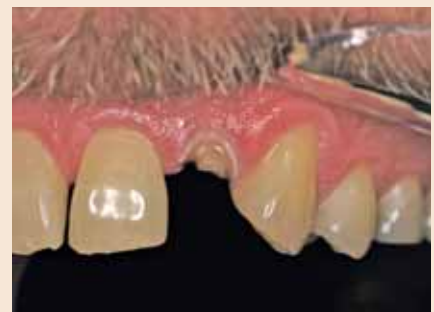
**FIGURE 3**—Fractured tooth.

The second case deals with anterior immediate tooth replacement (Fig. 3). The tooth was removed and the extraction socket

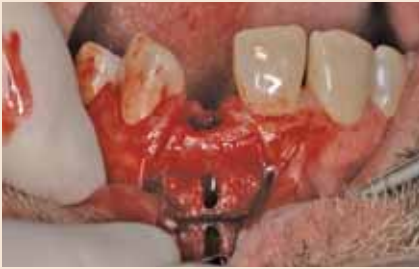
**FIGURE 4**—Buccal fenestration.

was probed to ensure intact walls. A buccal wall perforation was detected at the apex therefore a full thickness flap was reflected (Fig. 4). This revealed a buccal fenestration at the apical position.

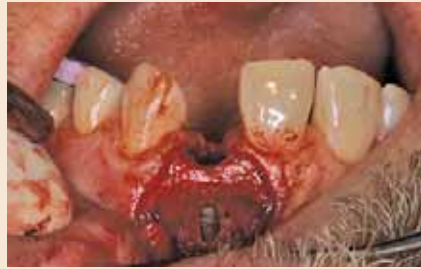
**FIGURE 5**—Immediate implant placed.

The adjacent bone was perforated. An appropriately tapered implant was inserted (Fig. 5) and the opening was covered with grafting material (Bio Oss, Geistlich Sohne AG, Wolhusen, Switzerland) (Fig.

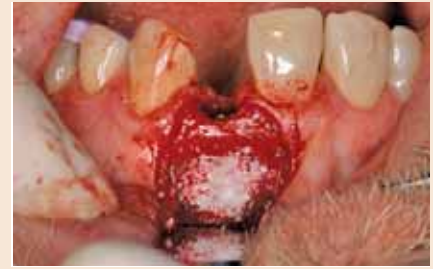
**FIGURE 6**—Graft material.

6) and a resorbable membrane (BioGuide, Geistlich Sohne AG, Wolhusen, Switzerland) (Fig. 7). The flap was closed, but due to the site lacking tissue at the extraction opening, a connective tissue graft was placed (Figs. 8 & 9) to establish primary closure.

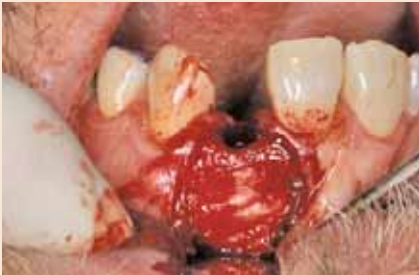
**FIGURE 7**—Resorbable membrane.

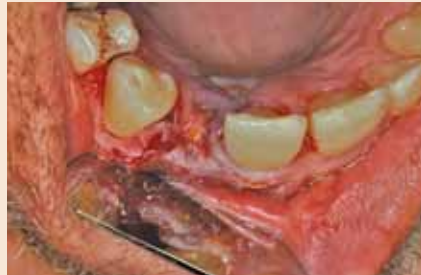
**FIGURE 8**—Connective tissue graft.

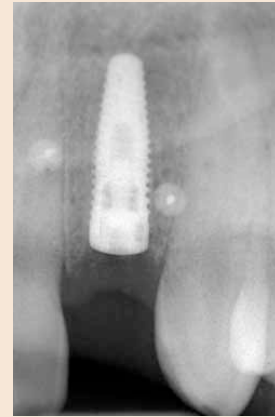
**FIGURE 9**—Implant radiograph.

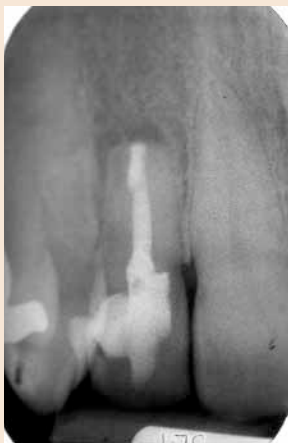
**FIGURE 10**—Infected tooth.

had root canal therapy, non-surgical retreatment, and apicoectomy (Fig. 10). The tooth still presents with a buccal fistula located at the apical region. This case is not suitable for immediate tooth replacement or immediate grafting following tooth removal due to active infection (Fig. 11). The tooth (Fig. 12) is first removed to eliminate the source of infection and allow soft tissue closure. Examination of the proposed graft/implant site may also be done at this time.

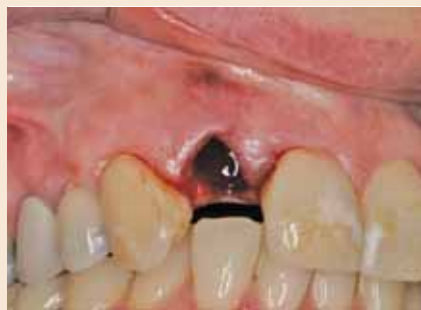
**FIGURE 11**—Tooth removed (note: apical fistula).

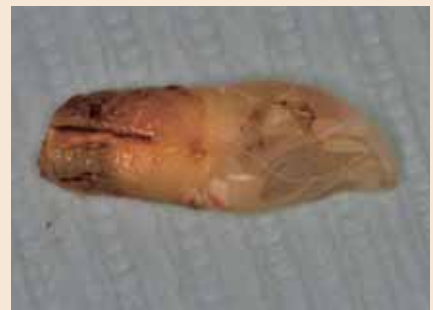
**FIGURE 12**—Fractured root.

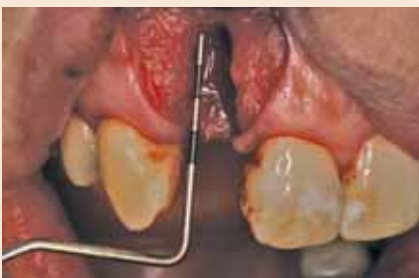
**FIGURE 13**—Missing buccal plate.

Following 6 weeks healing, the edentulous site is exposed, and degranulated in preparation for a monocortical block graft (Fig. 13). The area is perforated and the block is harvested from the symphysis (Fig. 14). The block is manipulated to fit the recipient site and fixed in place with a screw (Fig. 15). Primary coverage is established with periosteal releasing incisions and interrupted sutures. The patient's tooth is bonded (Fig. 16) back to the adjacent teeth without any pressure on the graft site. Following four months healing the site is now ready for implant placement (Fig. 17).

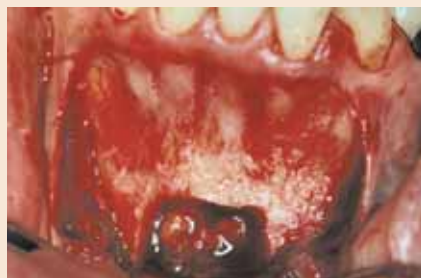
**FIGURE 14**—Donor site.

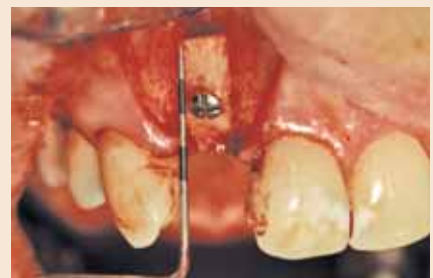
**FIGURE 15**—Monocortical graft in place.

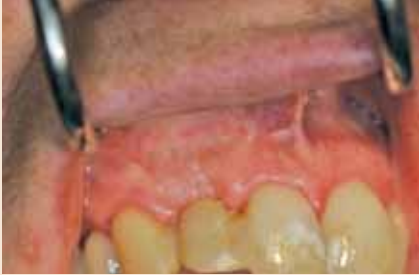
**FIGURE 16**—Temporary tooth bonded.

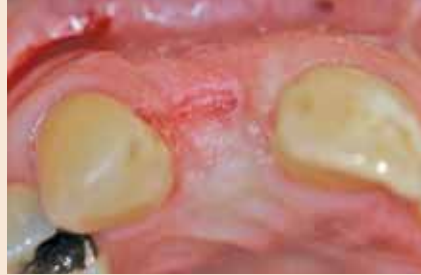
**FIGURE 17**—Healed graft site.

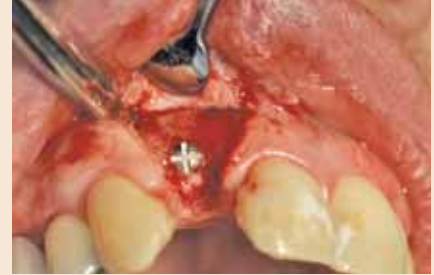
**FIGURE 18**—Seamless union.

Full flap reflection reveals seamless integration of the graft and the screw (Fig. 18) is removed. The osteotomy is prepared (Fig. 19) and the implant is inserted (Fig. 20). Primary closure is obtained (Fig. 21) and the patient's tooth is rebonded (Fig. 22).

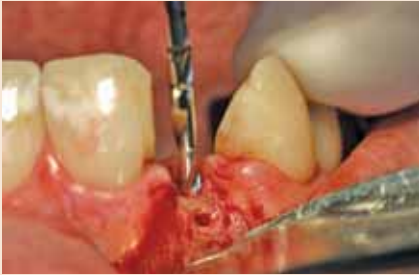
**FIGURE 19**—Osteotomy prepared.

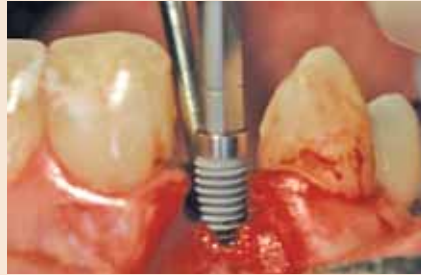
**FIGURE 20**—Implant placed.

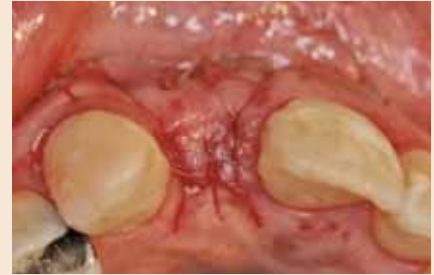
**FIGURE 21**—Primary closure.

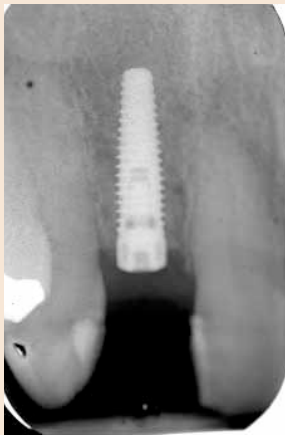
**FIGURE 22**—Implant radiograph.
